INDOOR AIR QUALITY ASSESSMENT

**Shaker Lane School
35 Shaker Lane
Littleton, MA 01460**

Prepared by:
Massachusetts Department of Public Health
Center for Environmental Health
Emergency Response/Indoor Air Quality Program
February 2006

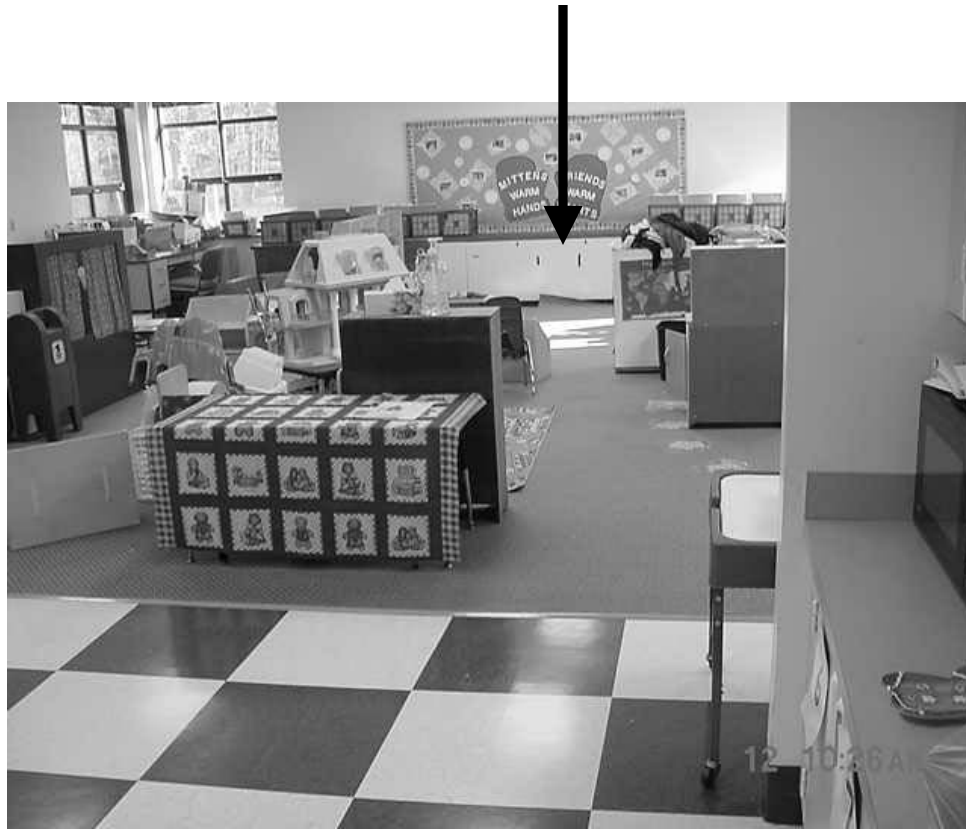
Picture 1

assistance. Floor covering in classrooms in this section of the building is composed of 80% carpeting and 20% tile (Picture 1); the carpeting is adhered directly on the cement slab (i.e., no backing/padding exists). Mr. Mahar reported that a heating pipe in classroom 104 broke on December 14, 2005, during the hours of school operation. Later that day, a carpet cleaning company was hired to extract the standing water and clean the carpeting, while the maintenance department attempted to turn off the valve to the heating pipe. Mr. Mahar reported that the carpet was found wet the following day due to continual leaks. The leaking continued for several days, until December 20, 2005 when a licensed plumber was able to locate and secure the valve, which was installed behind the heating unit. Mr. Mahar reported that although the leaking was continual, school maintenance staff extracted water from the carpet to prevent the water from becoming stagnant or a source for mold growth. Once the leak was repaired, the cleaning company was again contracted to extract water, shampoo and deodorize the carpet. The carpet was also mechanically dried with fans and heat to speed drying. The classroom has not been occupied since the water damage occurred.

**Long View of Classroom 104 Showing Floor Covering; 80% Carpet 20% Tile,
Note Univent against Rear Wall Where Leak Occurred**

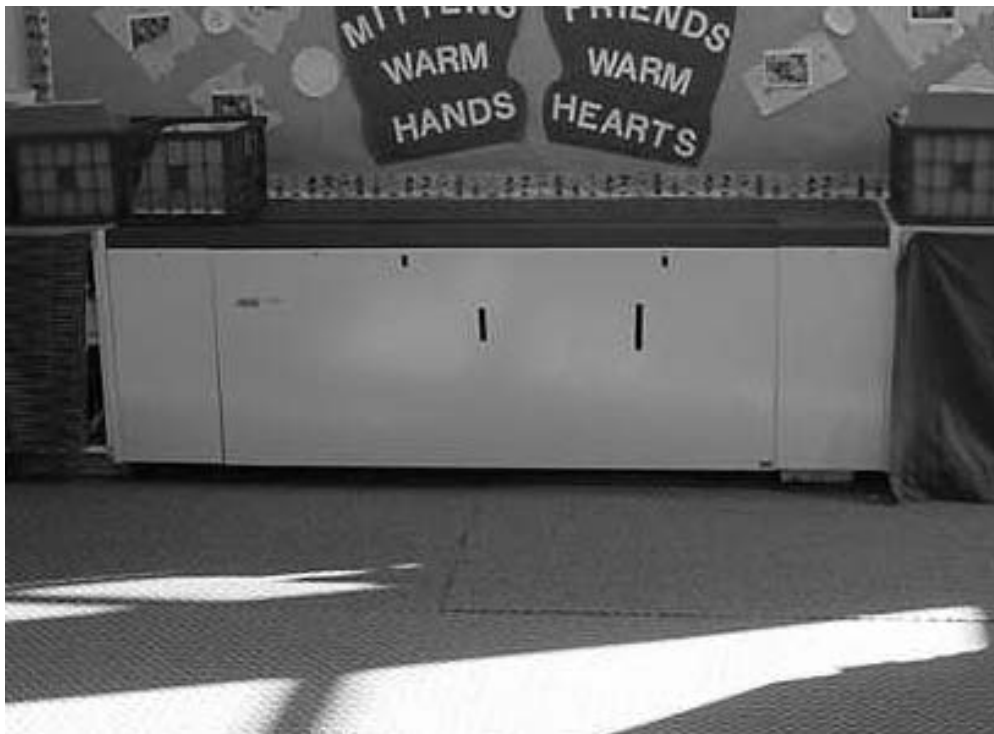
Picture 2

Modern Univent in 1998 Section of Building

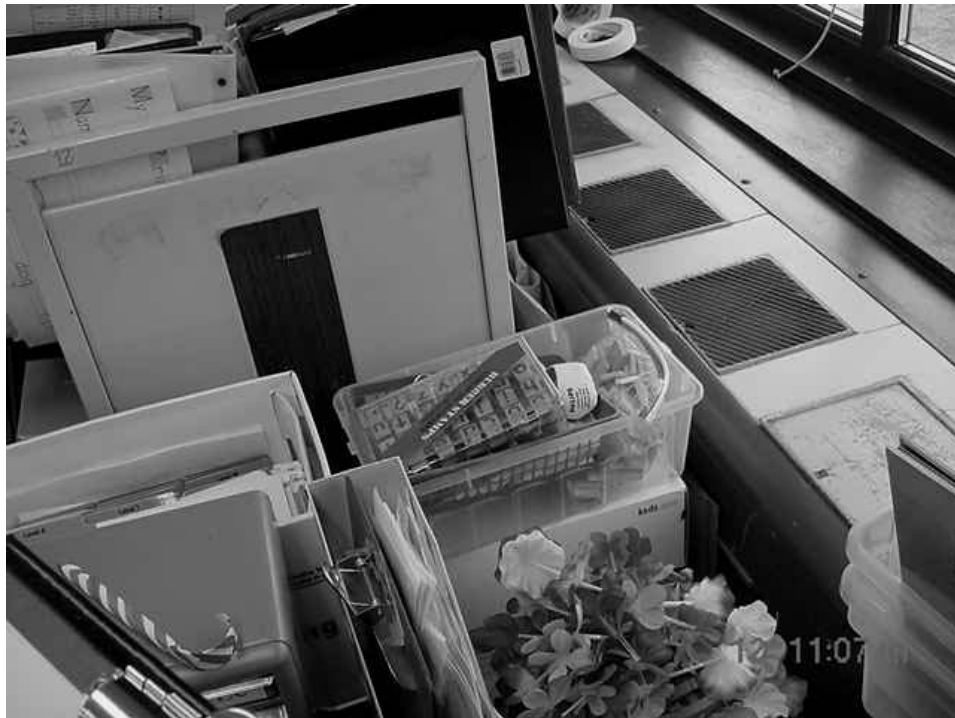
Picture 3

Fresh air in classrooms is supplied by unit ventilator (univent) systems (Picture 2). A univent draws air from outdoors through a fresh air intake located on the exterior wall of the building and returns air through an air intake located at the base of the unit ([Figure 1](#)). Fresh and return air are mixed, filtered, heated and provided to classrooms through a diffuser located on the top of the unit. Adjustable louvers control the ratio of fresh and recirculated air. Obstructions to airflow, such as furniture located in front of and/or materials stored on univents, were observed in some areas (Picture 3), despite labels restricting placement of

**Classroom Materials up against front of Classroom Univent
Where Return Vent is Located (Bottom Front)**

1. Continue with plans to repair rooftop exhaust motors.
2. Remove all blockages from univents and exhaust vents.
3. Continue to operate both supply and exhaust ventilation continuously during periods of school occupancy. To maximize air exchange keep classroom doors shut.
4. Use openable windows in conjunction with classroom univents and exhaust vents to increase air exchange. Care should be taken to ensure windows are properly closed at night and weekends to avoid the freezing of pipes and potential flooding.
5. Consider balancing mechanical ventilation systems every 5 years, as recommended by ventilation industrial standards (SMACNA, 1994).

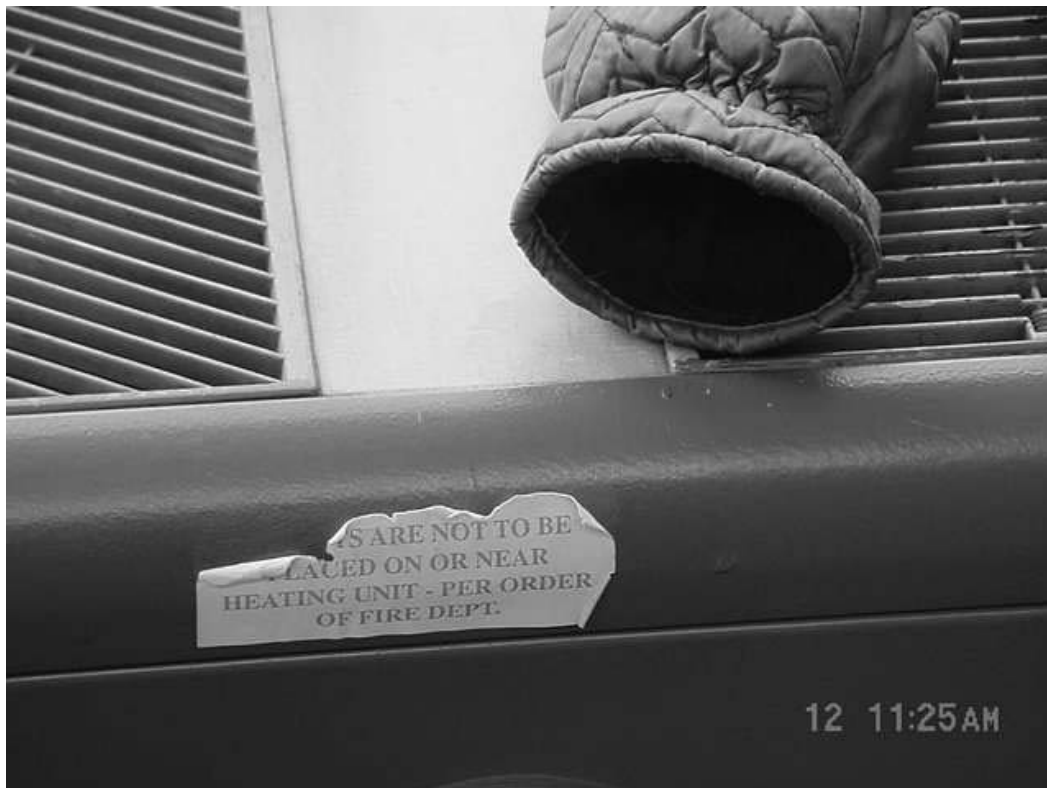
Picture 4

objects on heating units per order of the fire department (Picture 4). In order for univents to provide fresh air as designed, these units must remain free of obstructions. In addition, univents in the 1960 and 1971 portions of the building are reportedly original equipment, 35 to 45 years old. Univents of this age are difficult to maintain because replacement parts are often unavailable.

Gloves Drying on Univent Despite Label Instructing Not to Place Objects on or Near Heating Unit per Order of Fire Dept

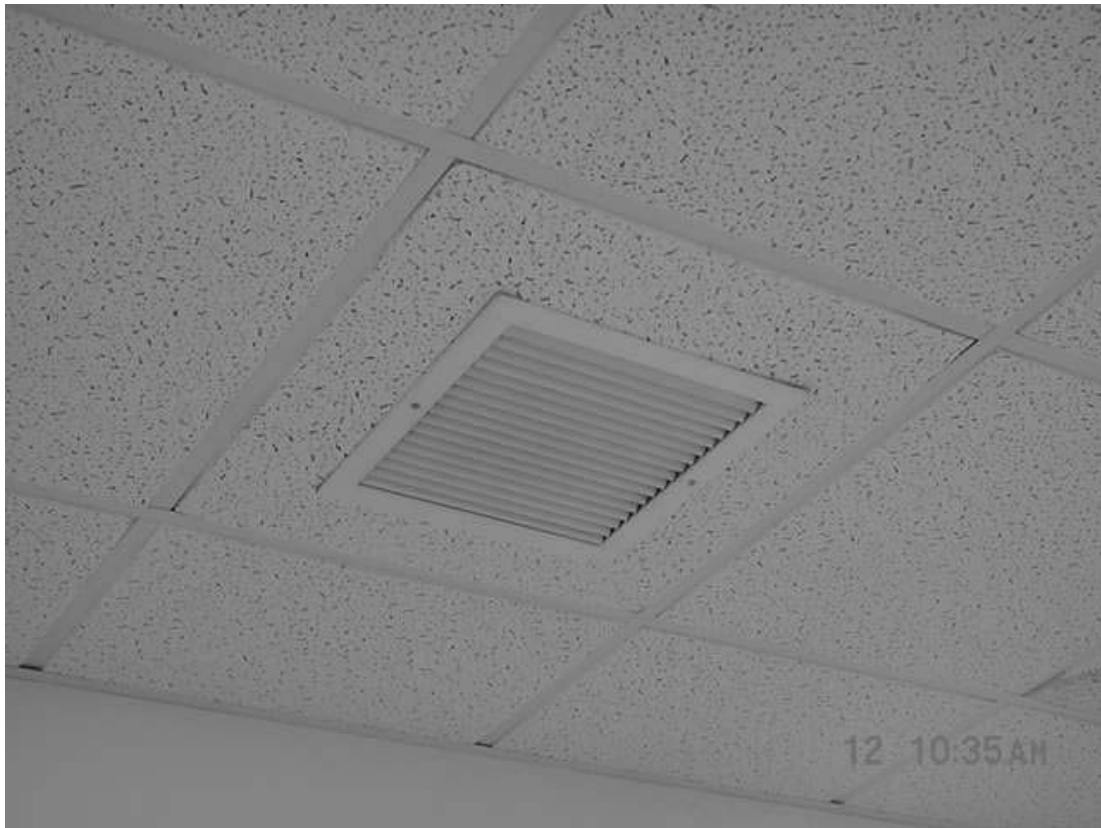
Picture 5

Ceiling-Mounted Exhaust Vent

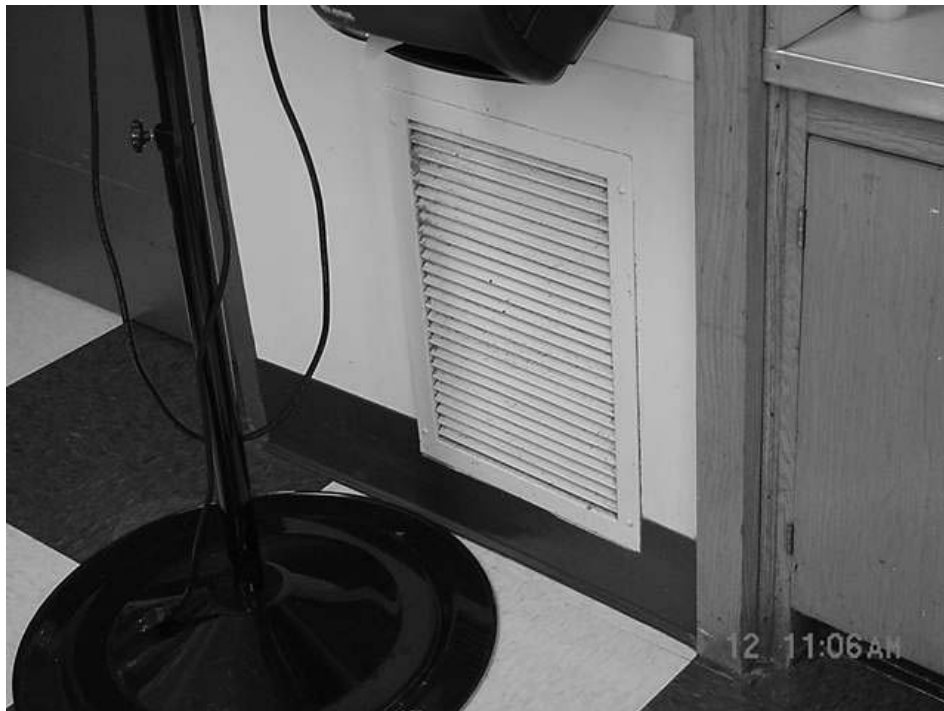
Picture 6

Wall-Mounted Exhaust Vent

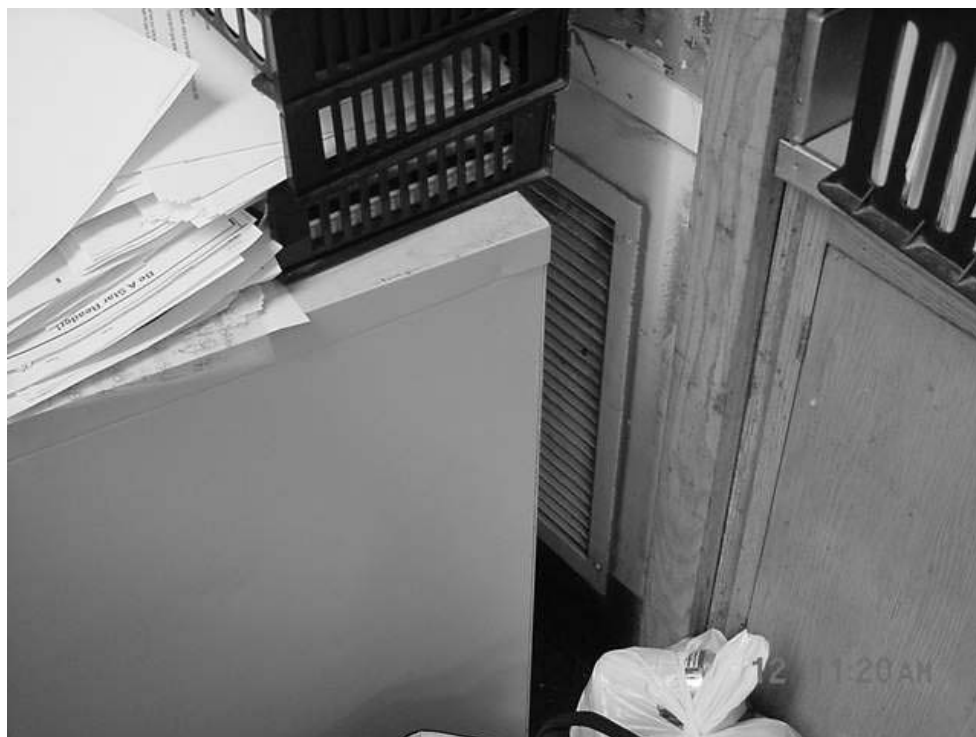
Picture 7

Wall-Mounted Exhaust Vent Entirely Blocked by File Cabinet, Cabinet Pulled Away for Photo Op by MDPH Staff

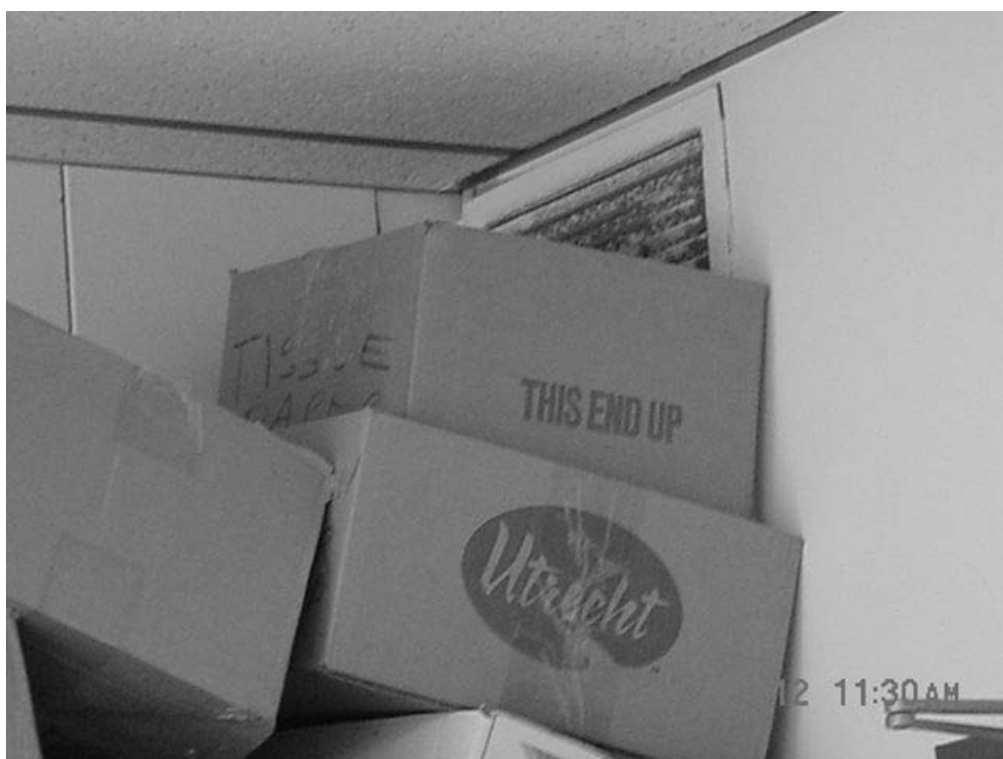
Picture 8

Wall-Mounted Exhaust Vent Partially Obstructed by Boxes

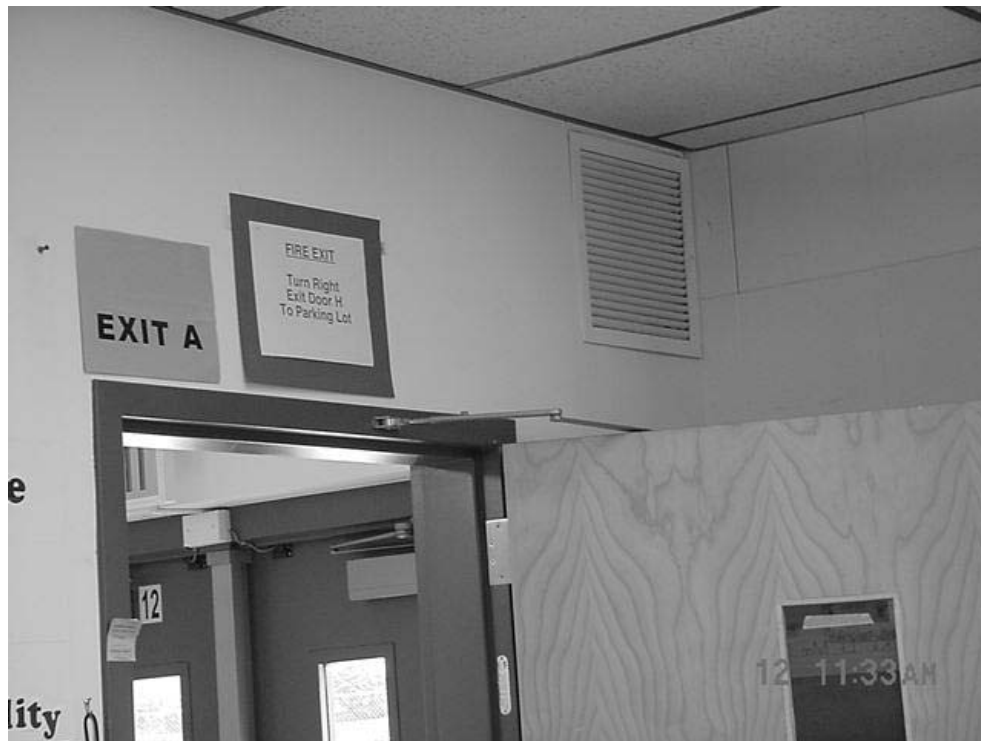
Picture 9

Proximity of Wall-Mounted Exhaust Vent to Open Hallway Door

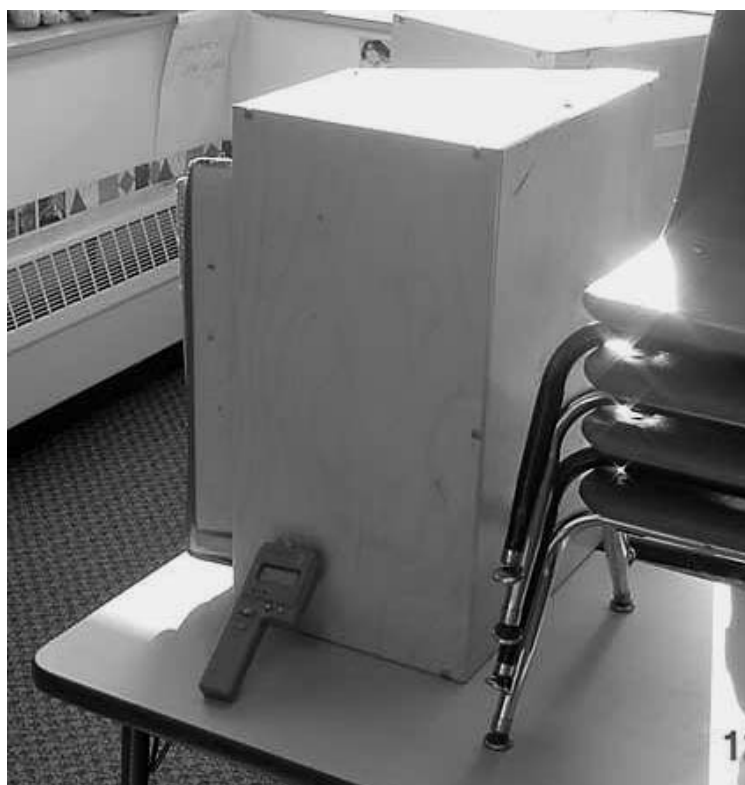
Picture 10

Moisture Testing of the Bottom of Wooden Shelves in Contact With Carpeting

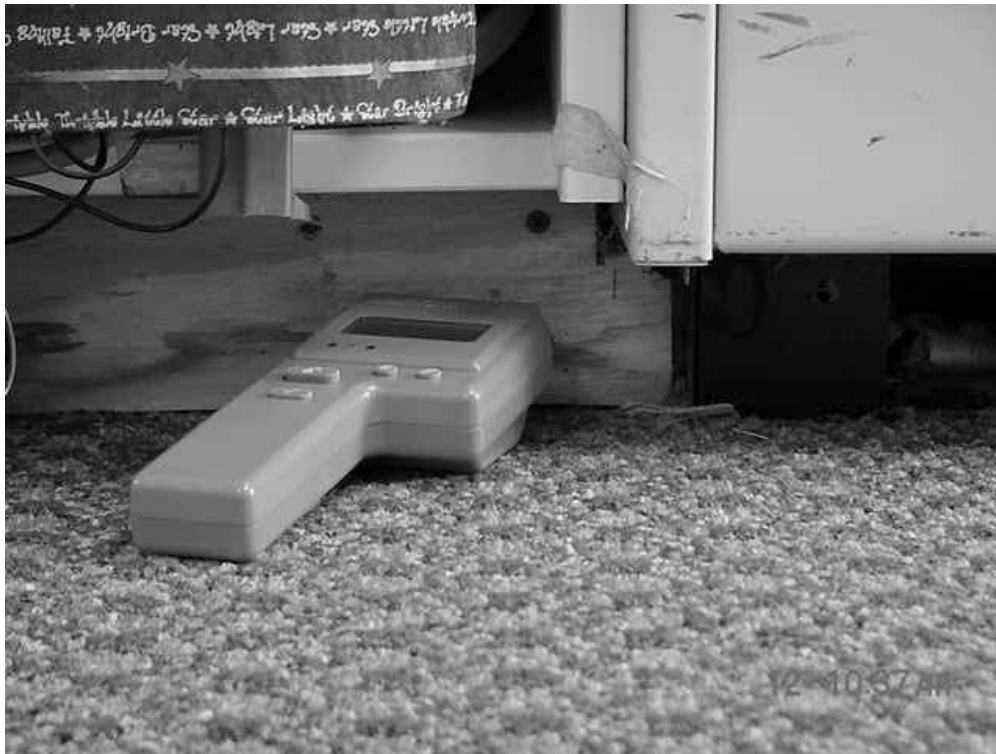
Picture 11

Moisture Testing of the Wooden Baseboard in Contact With Carpeting, Note Water Stain on Baseboard

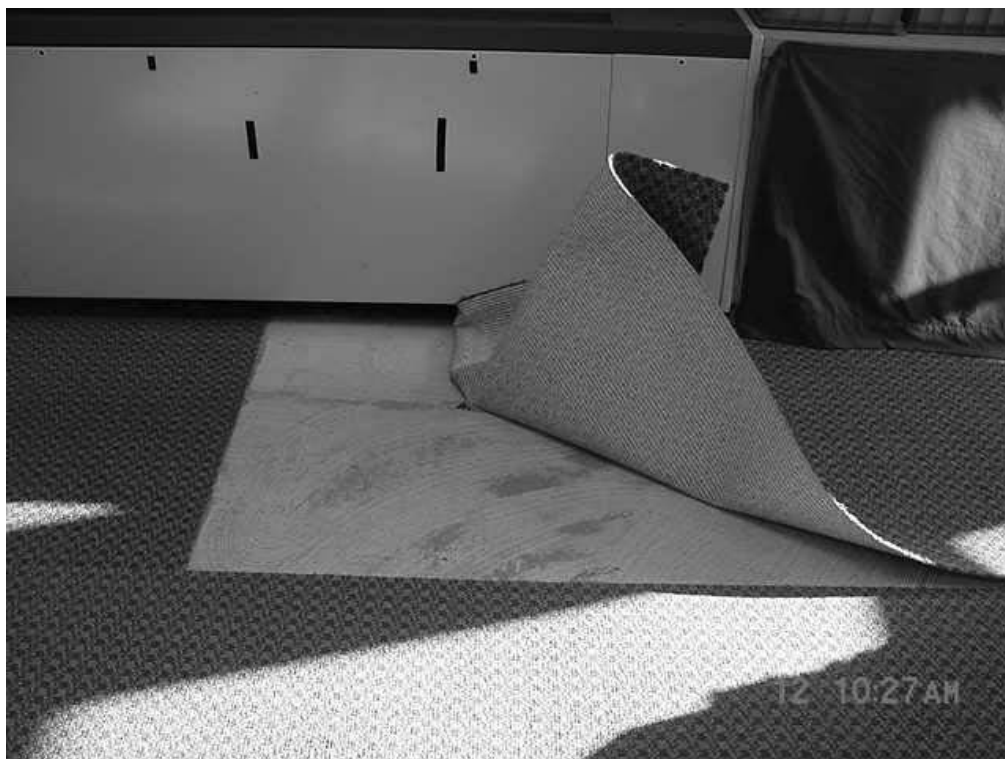
Picture 12

In addition, MDPH staff conducted a thorough visual examination of materials in classroom 104. Materials examined include areas beneath damaged carpeting (which required the removal of carpeting in the area) (Pictures 12 and 13), as well as shelving, area carpeting, wooden baseboard, walls and furniture. No visible mold growth or associated odors were observed and/or detected during the assessment.

Carpeting Removed in Classroom 104, Note no Padding or Backing, Dark Stains on Cement Slab Indicate Adhesive Application

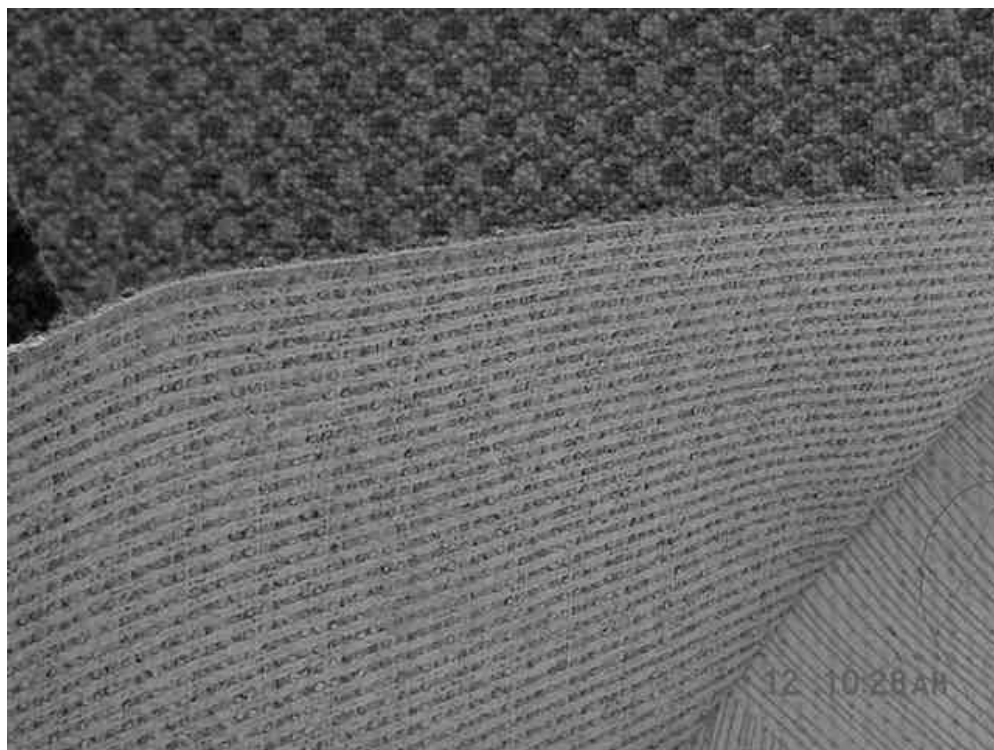
Picture 13

Close-Up of Back of Carpeting in Classroom 104

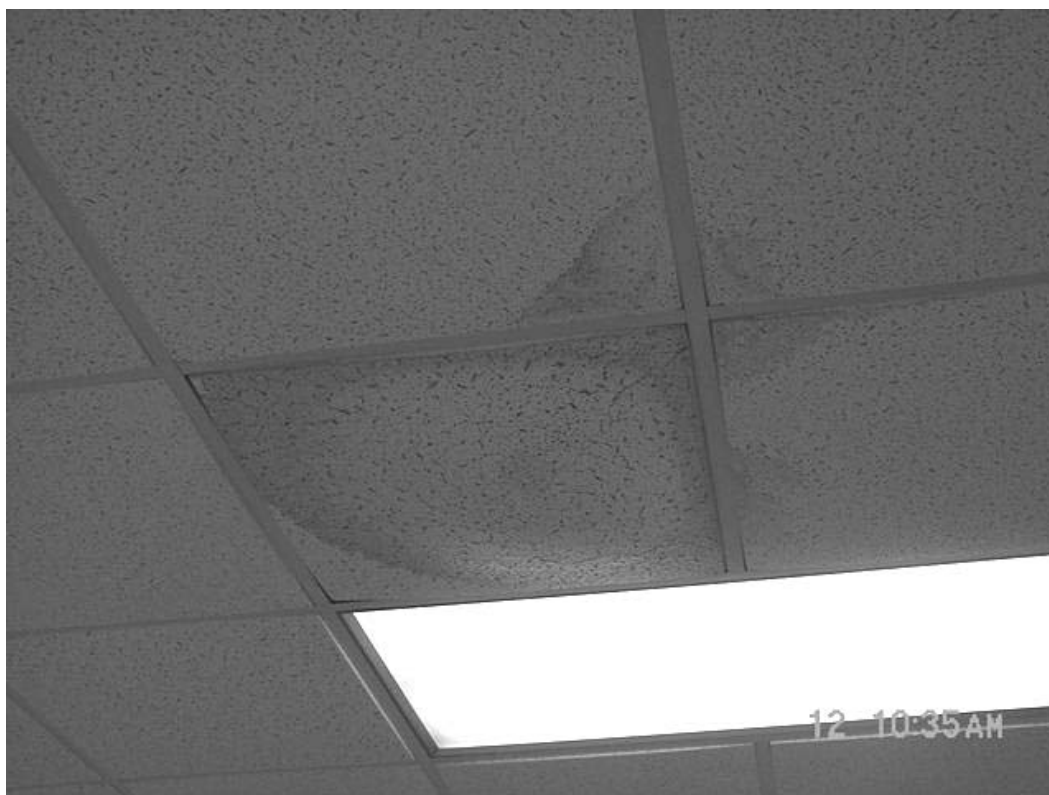
Picture 14

Although no evidence of mold growth related to the plumbing leak was detected/observed, other sources of potential mold growth were observed. Several water damaged ceiling tiles were observed in classroom 104 (Picture 14). Hallways and classrooms

in other portions of the building also had water damaged ceiling tiles (Table 1). Water damaged ceiling tiles in the library were reported to be a result of condensation from the air conditioning system. Water damaged ceiling tiles can provide a source of mold and should be replaced after a water leak is discovered and repaired.

Water Damaged/Bulging Ceiling Tiles in Classroom 104

7. Ensure roof and/or plumbing leaks are repaired, and replace any remaining water-stained. Examine the space above and around these areas for mold growth. Disinfect areas of water leaks with an appropriate antimicrobial.

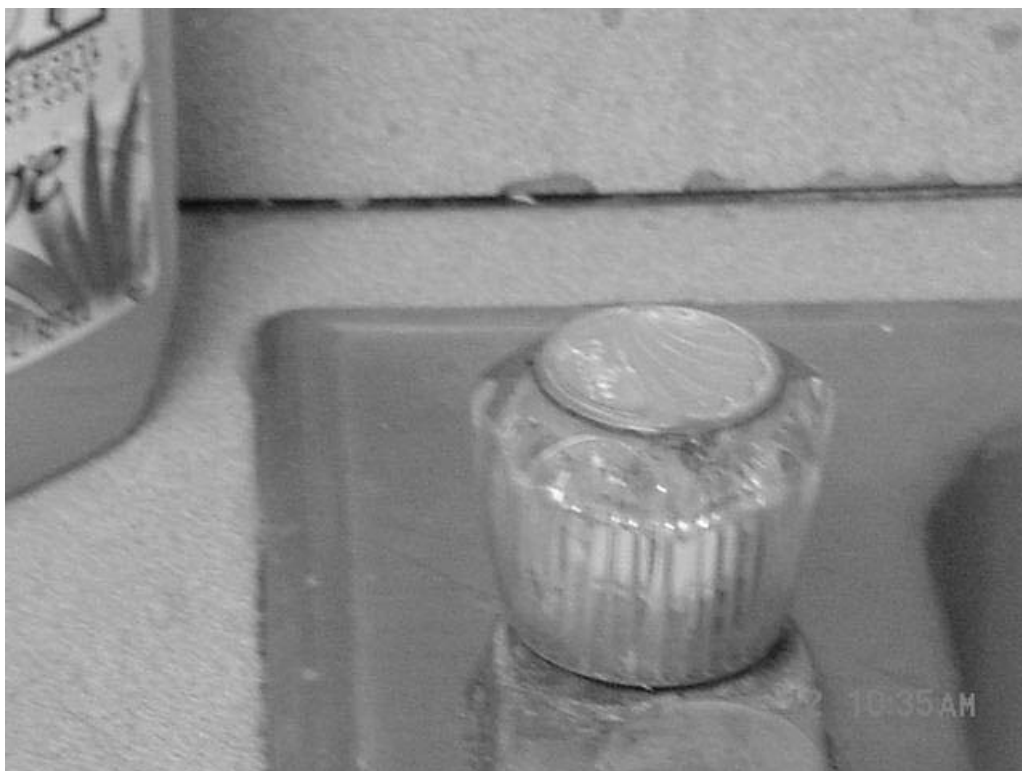
Picture 15

Spaces between the sink countertop and backsplash were observed in several classrooms (Picture 15/Table 1). Improper drainage or sink overflow can lead to water penetration of countertop wood, the cabinet interior and behind cabinets. Like other porous materials, if these materials become wet repeatedly they can provide a medium for mold growth.

Spaces between Backsplash and Sink Countertop in Classroom 104

8. Seal areas around sinks to prevent water-damage to the interior of cabinets and adjacent wallboard.
9. Ensure all plants are equipped with drip pans. Examine drip pans for mold growth and disinfect areas of water leaks with an appropriate antimicrobial where necessary.
Move plants away from univents in classrooms.

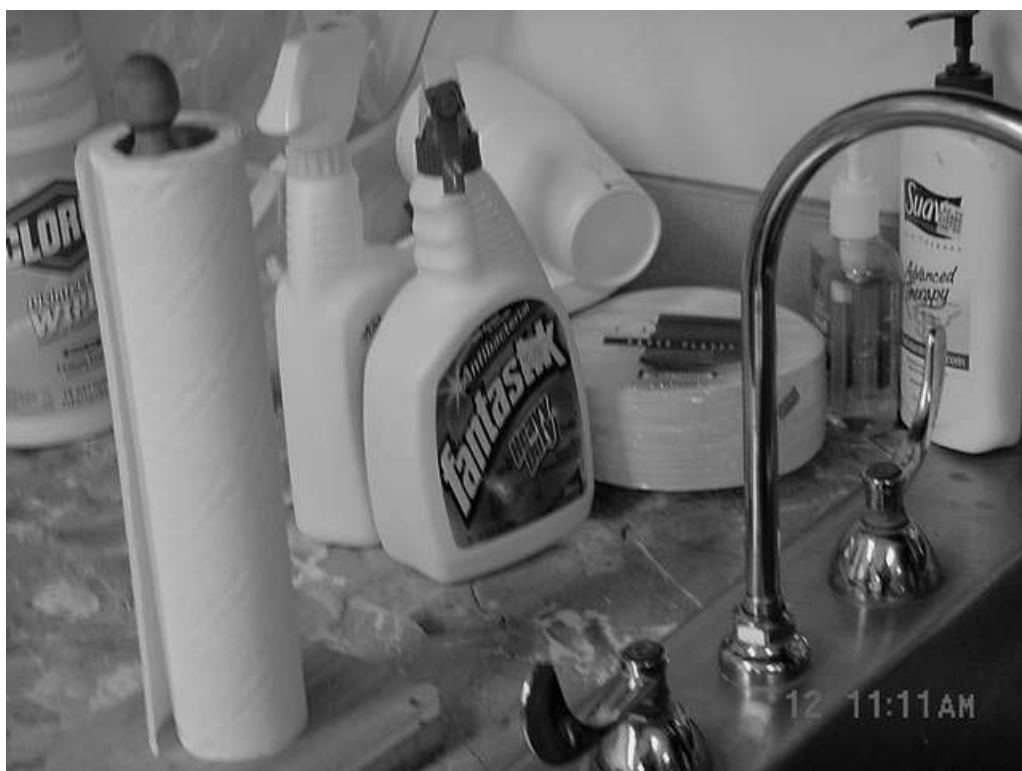
Picture 16

Please note, TVOC air measurements are only reflective of the indoor air concentrations present at the time of sampling. Indoor air concentrations can be greatly impacted by the use of VOC-containing products. While no measurable TVOC levels were detected in the indoor environment, VOC-containing materials were noted. Several classrooms contained dry erase boards and dry erase board markers. Materials such as dry erase markers and dry erase board cleaners may contain VOCs, such as methyl isobutyl ketone, n-butyl acetate and butyl-cellusolve (Sanford, 1999), which can be irritating to the eyes, nose and throat. Cleaning products were found on countertops and beneath sinks in a number of classrooms (Picture 16). Cleaning products contain VOCs and other chemicals, which can be

irritating to the eyes, nose and throat and should be stored properly and kept out of reach of students.

Spray Cleaning Products on Countertop in Classroom

10. Store cleaning products properly and out of reach of students.
11. Clean univent air diffusers and exhaust vents periodically of accumulated dust.
12. Relocate or consider reducing the amount of materials stored in classrooms to allow for more thorough cleaning. Clean items regularly with a wet cloth or sponge to prevent excessive dust build-up.

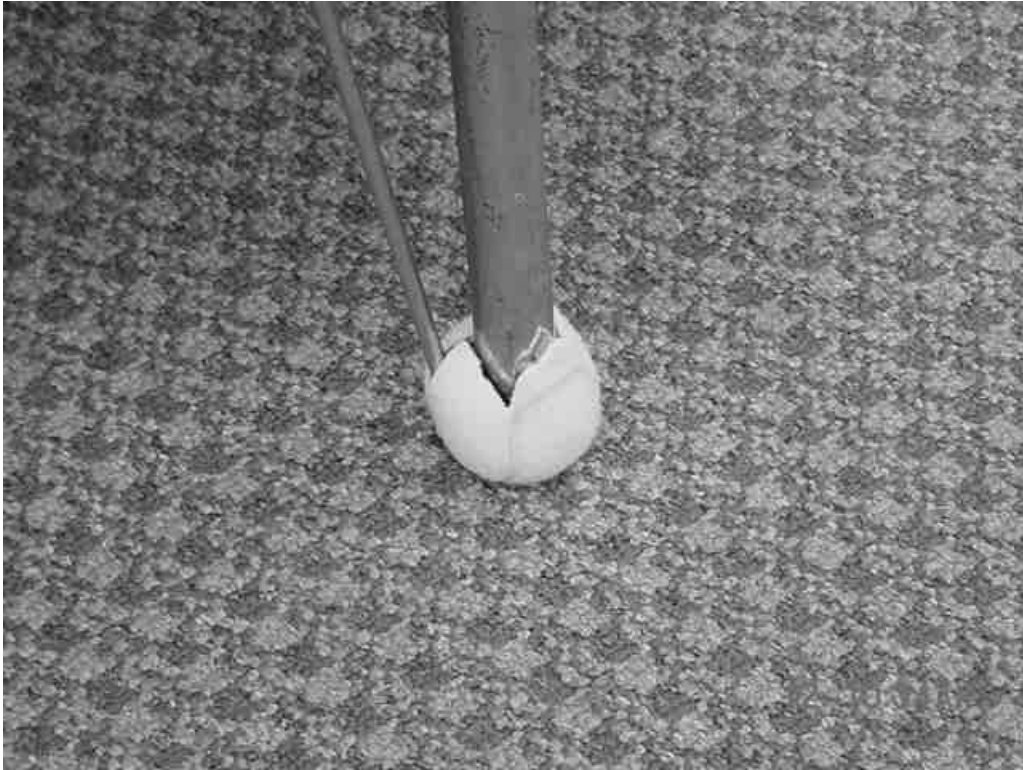
Picture 17

In an effort to reduce noise from sliding chairs, tennis balls had been sliced open and placed on chair legs (Picture 17). Tennis balls are made of a number of materials that are a source of respiratory irritants. Constant wearing of tennis balls can produce fibers and cause TVOCs to off-gas. Tennis balls are made with a natural rubber latex bladder, which becomes abraded when used as a chair leg pad. Use of tennis balls in this manner may introduce latex dust into the school environment. Some individuals are highly allergic to latex (e.g., spina bifida patients) (SBAA, 2001). It is recommended that the use of materials containing latex be limited in buildings to reduce the likelihood of symptoms in sensitive individuals (NIOSH, 1997). A question and answer sheet concerning latex allergy is attached as [Appendix B](#) (NIOSH, 1998).

Tennis Ball on Table Leg in Classroom

14. Consider discontinuing the use of tennis balls on chair legs to prevent latex dust generation. Alternative “glides” can commonly be purchased from office supply stores; see Picture 22 for an example.

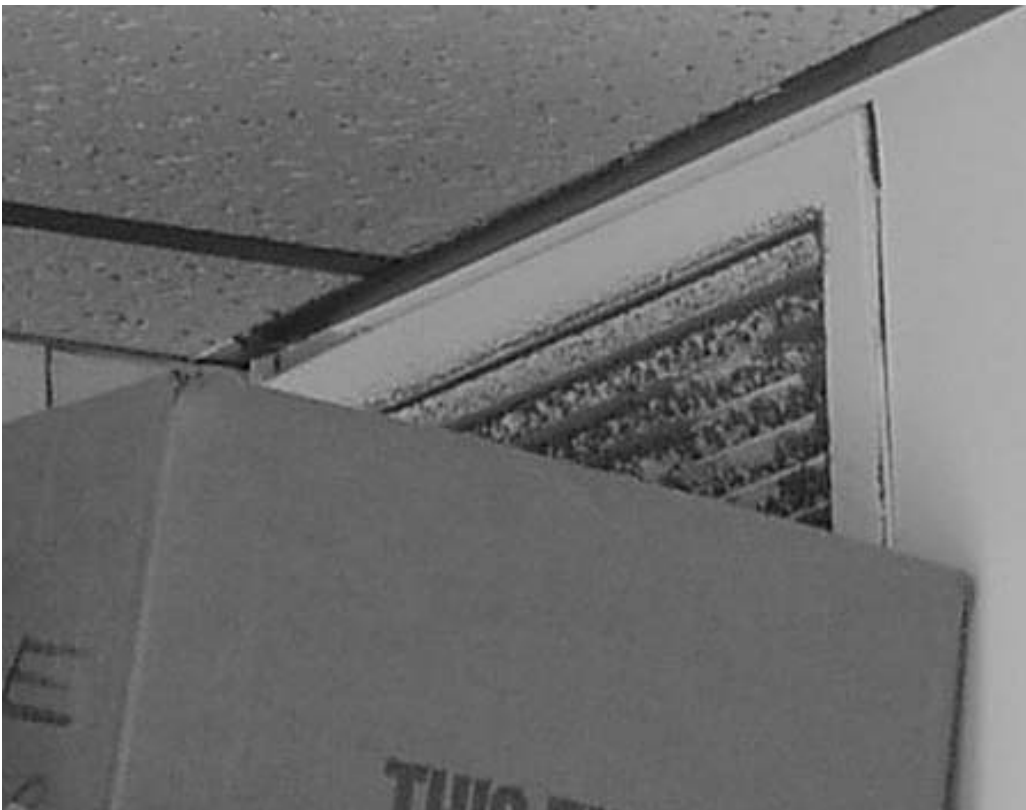
Picture 18

A number of exhaust vents and personal fans in classrooms had accumulated dust (Pictures 18 and 19). If exhaust vents are not functioning, backdrafting can occur, which can re-aerosolize dust particles. Dust particles can also be aerosolized when fans are activated. Dust can be irritating to eyes, nose and respiratory tract.

Accumulated Dust/Debris on Classroom Exhaust Vent

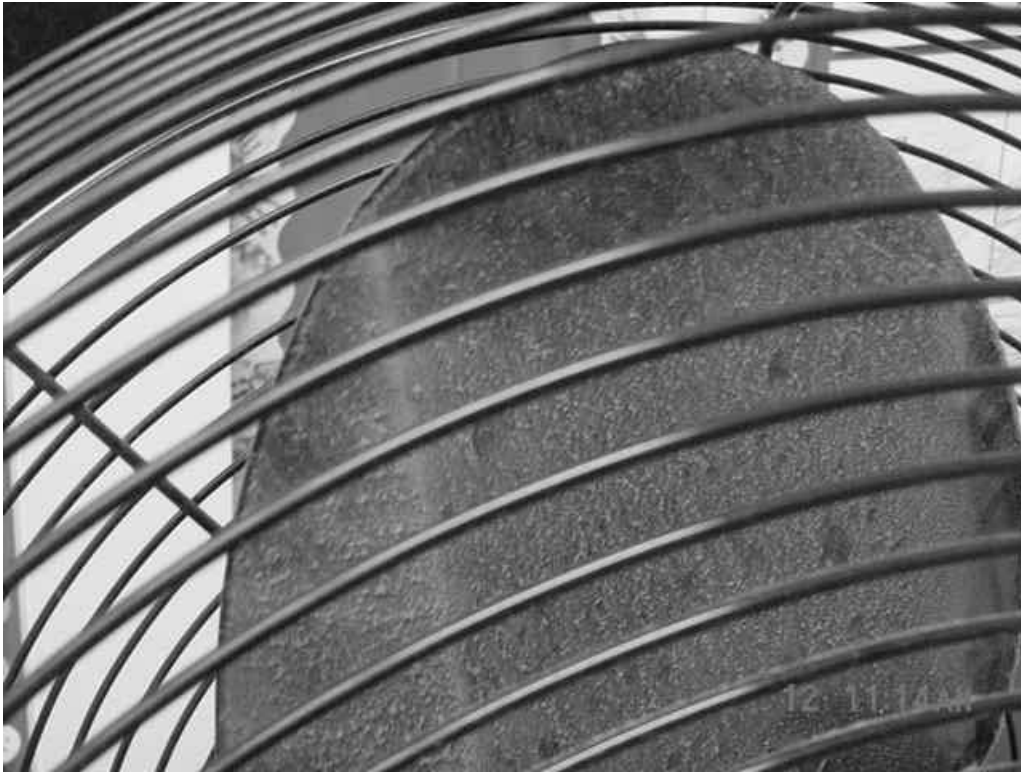
Picture 19

Accumulated Dust on Fan Blade in Classroom

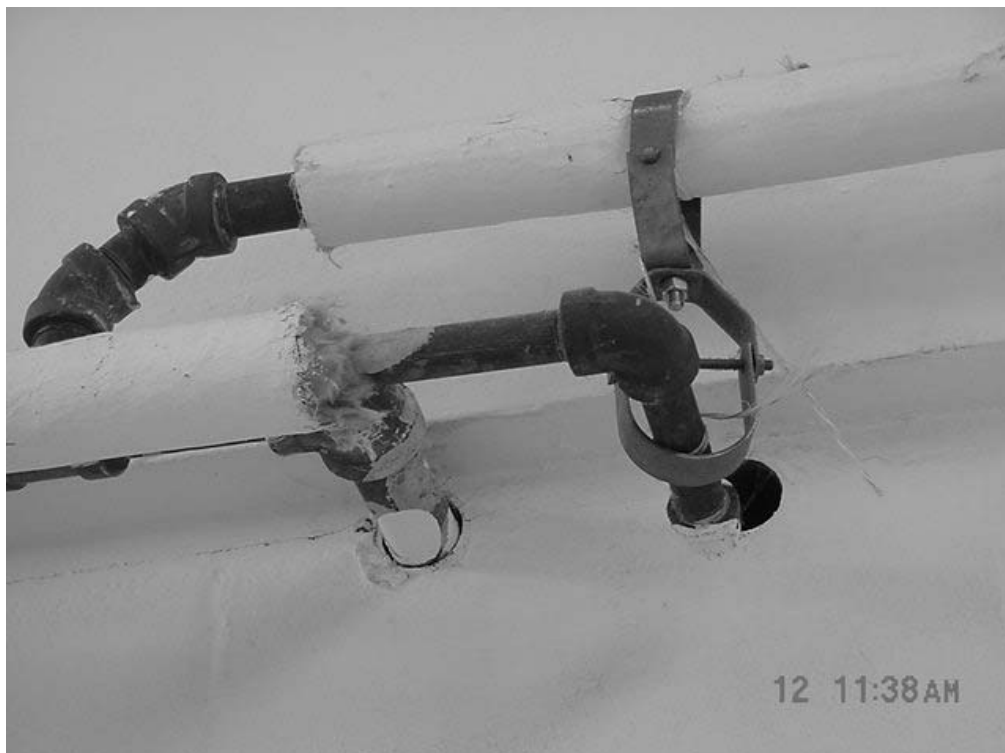
Picture 20

Exposed fiberglass insulation around pipes and open utility holes were observed in the gymnasium (Picture 20). Fiberglass insulation can be a source of skin, eye and respiratory irritation to sensitive individuals. Open utility holes can serve as a means for odors, dusts and particulates to migrate between rooms and floors.

Exposed Fiberglass and Open Utility Holes in Gymnasium

13. Seal breaches around utility holes (Picture 20) and replace missing ceiling tiles (Picture 21) to prevent the migration of odors, dust and particulate matter between areas.

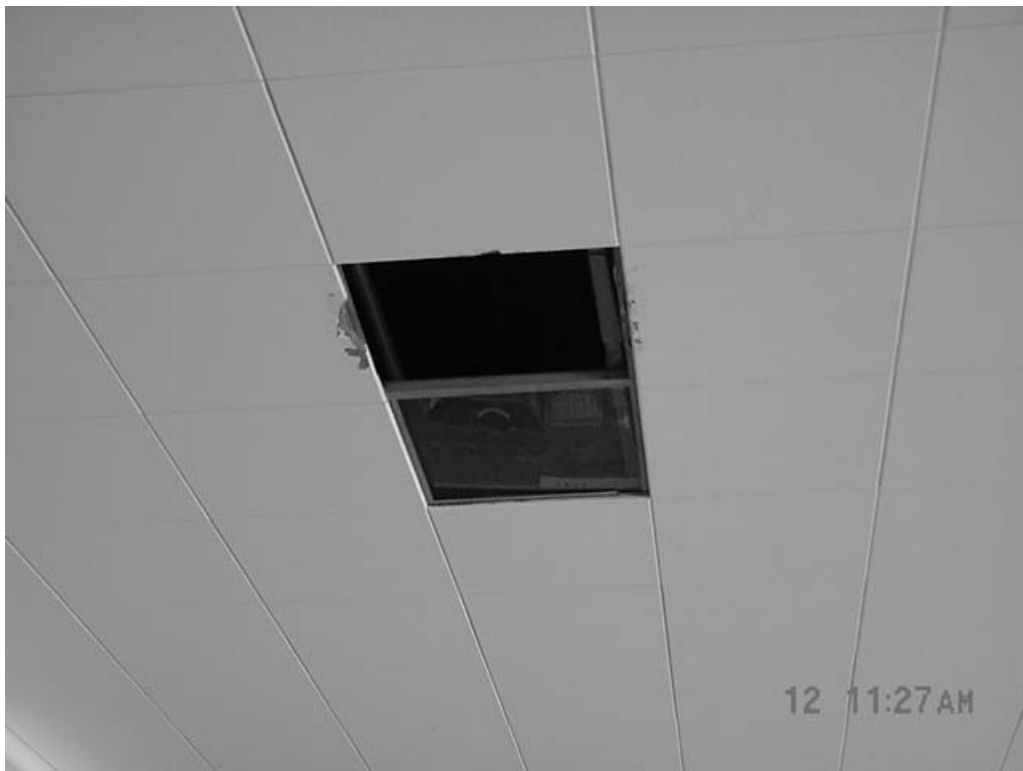
Picture 21

Lastly, missing ceiling tiles were observed in a number of areas (Picture 21). Missing/ajar ceiling tiles can provide a pathway for movement of materials (e.g. odors, dust, particulate) from unoccupied areas to occupied areas. Missing ceiling tiles should be replaced flush to ceiling system to prevent such movement.

Missing Ceiling Tiles in Classroom 210

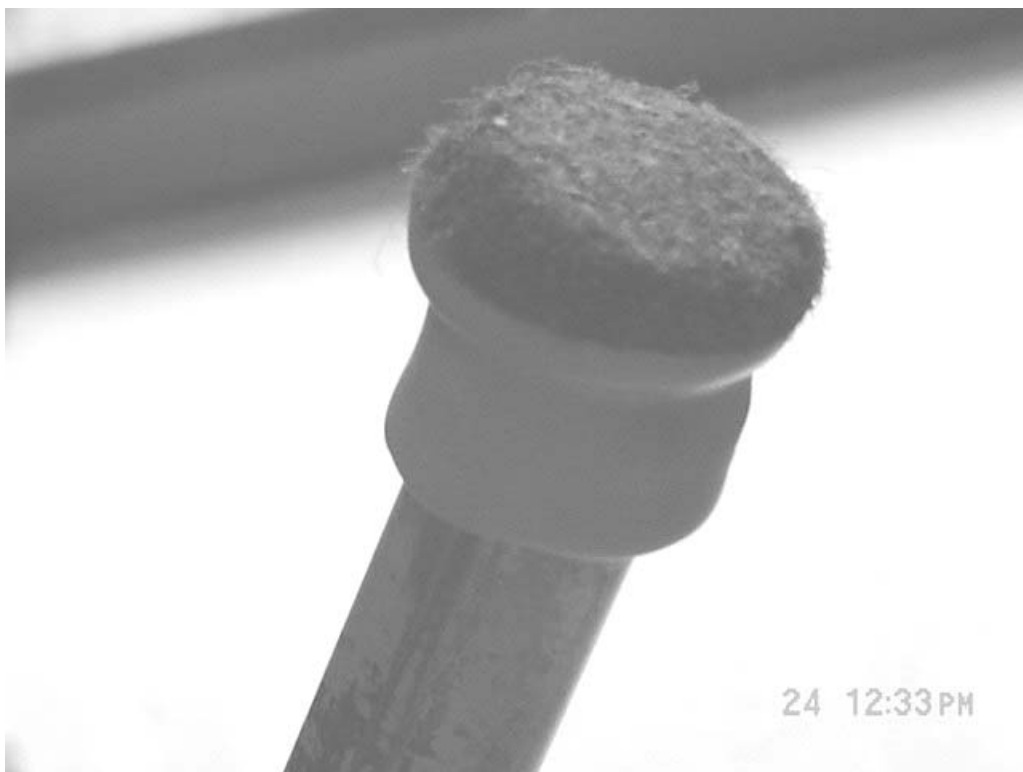
Picture 22

“Glides” for Chair Legs that can be used as an Alternative to Tennis Balls
